**BELMONT MILLS,
BELMONT, CO OFFALY:
INDUSTRIAL HERITAGE SURVEY**

Fred Hamond

for
Mr Thomas Dolan
May 2003

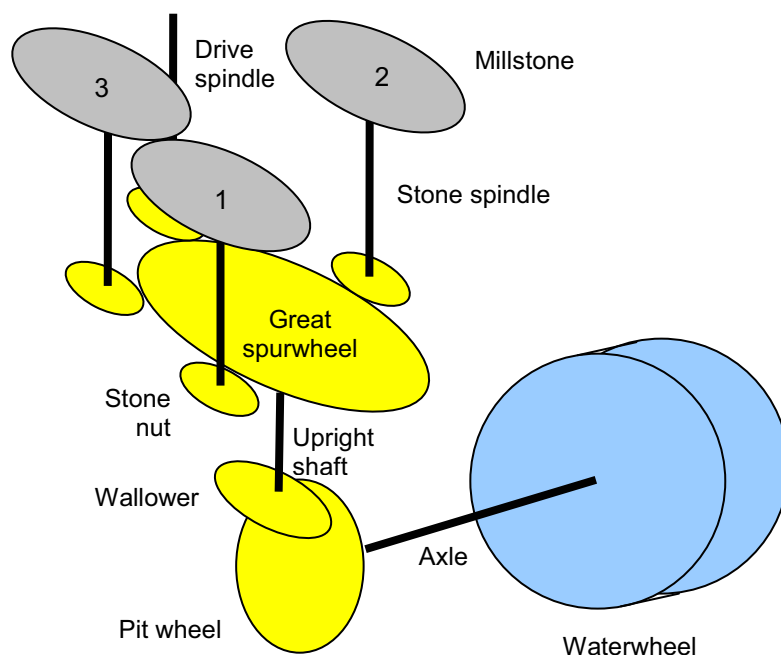
Fig.14 Schematic layout of drives to millstones.

The rotative power of the waterwheel was transmitted through a standard great spurwheel arrangement to three sets of millstones. There was also a drive off the great spurwheel to ancillary machinery for processing the grain and meal (fig.14).
